# Metallurgical examination of rockbolts failed in service due to stress corrosion cracking

## Abstract

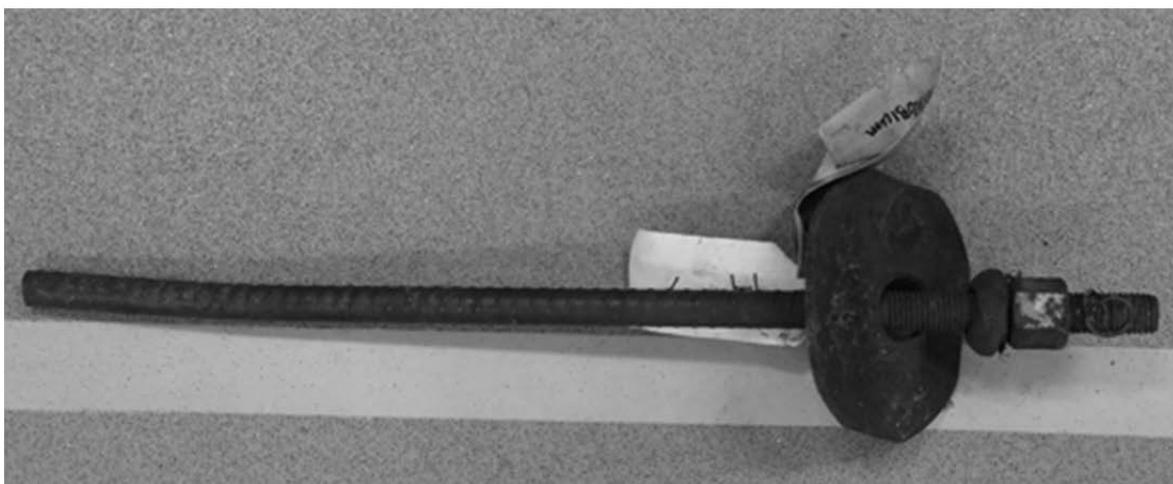
Sixty eight failed rockbolts from five different mines were obtained for the present study. The rockbolts had failed in a brittle manner, transverse to their axis, as is characteristic of SCC failure of rockbolts (Crosky et al., 2012). An example is shown in Figure 1. Only the section of bolt from the fracture to the threaded end was retrieved in each case, since the remainder of the bolt was still embedded in the rock. The retrieved sections varied from approximately 100–1,500 mm in length. Most of the bolts showed a discernible bend near the location of the fracture when examined along a straight edge. Otherwise, however, the retrieved section was essentially straight, as illustrated in Figure 1. All bolts had a diameter of 22 mm.

**Figure 1** Failed rockbolt as received (Rockbolt 2)

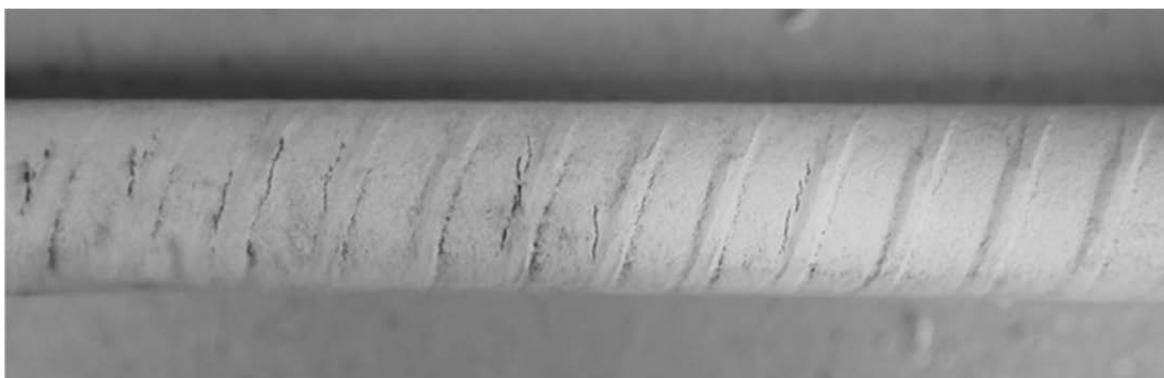
**Figure 2** Subcritical cracking along the ribs of Rockbolt 2 as revealed by magnetic particle inspection

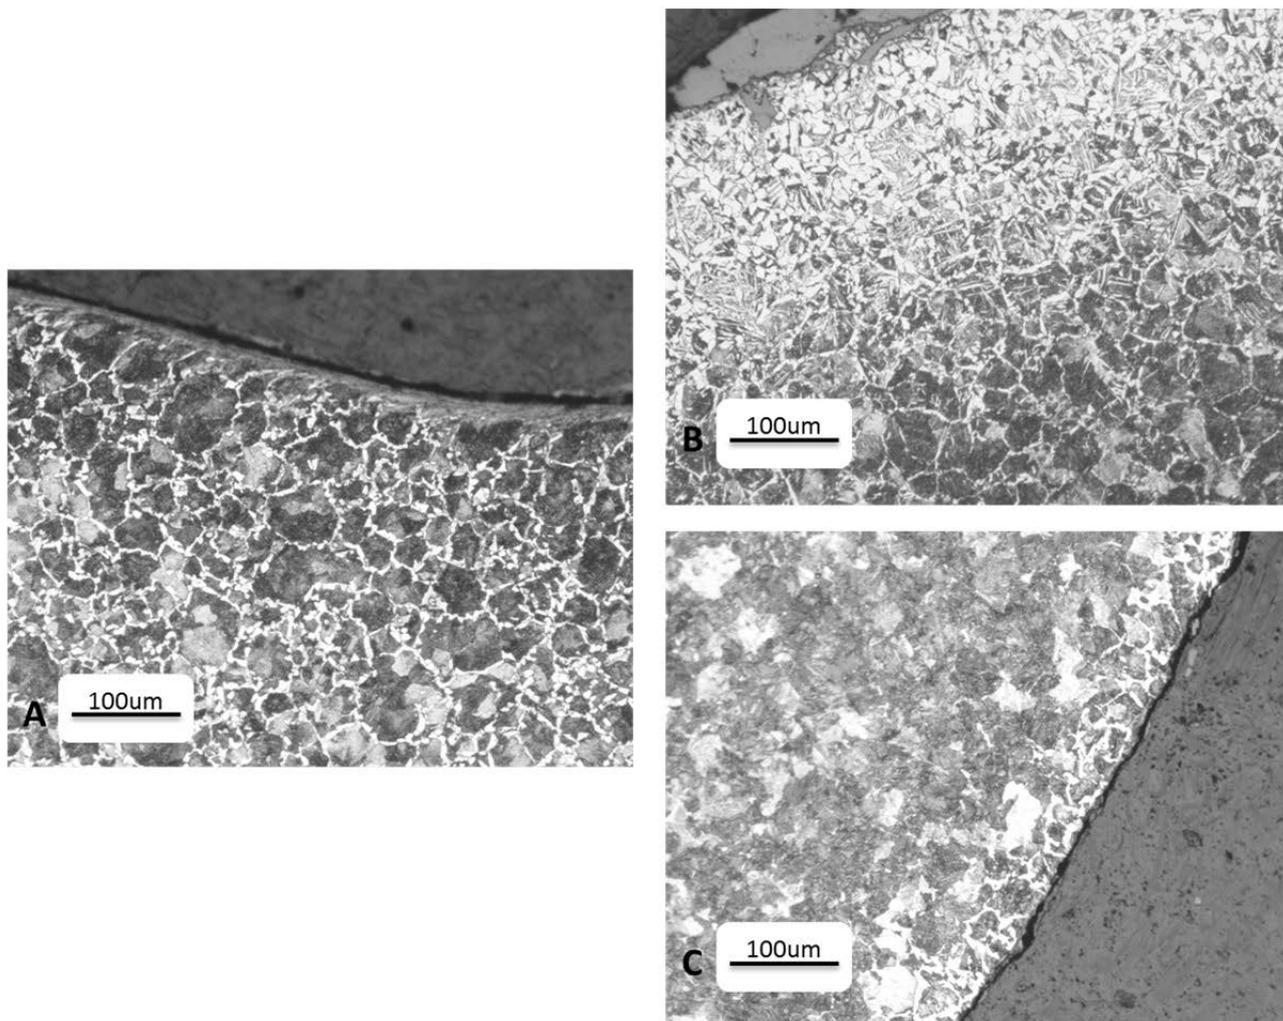
The microstructures of Rockbolt 1 (840 Grade steel) Rockbolt 7 (AISI 1355) and Rockbolt 4 (AISI 5155) are shown in Figure 3. All three rockbolts showed surface decarburisation which had resulted from the hot rolling process used in their manufacture. The 840 Grade steel had a mixed ferrite/pearlite structure. The AISI 1355 steel had a mostly pearlitic structure with just a small amount of ferrite at the prior austenite grain boundaries while the AISI 5155 steel was almost fully pearlitic. The low silicon 840 Grade steel (Rockbolt 5) had a similar microstructure to the 840 Grade steel. All steels contained longitudinal manganese sulphide inclusions (stringers), as is characteristic of air melted steels.

**Figure 3** Microstructure of (A) Rockbolt 1 (840 Grade steel), (B) Rockbolt 7 (AISI 1355 steel) and (C) Rockbolt 4 (AISI 5155 steel)

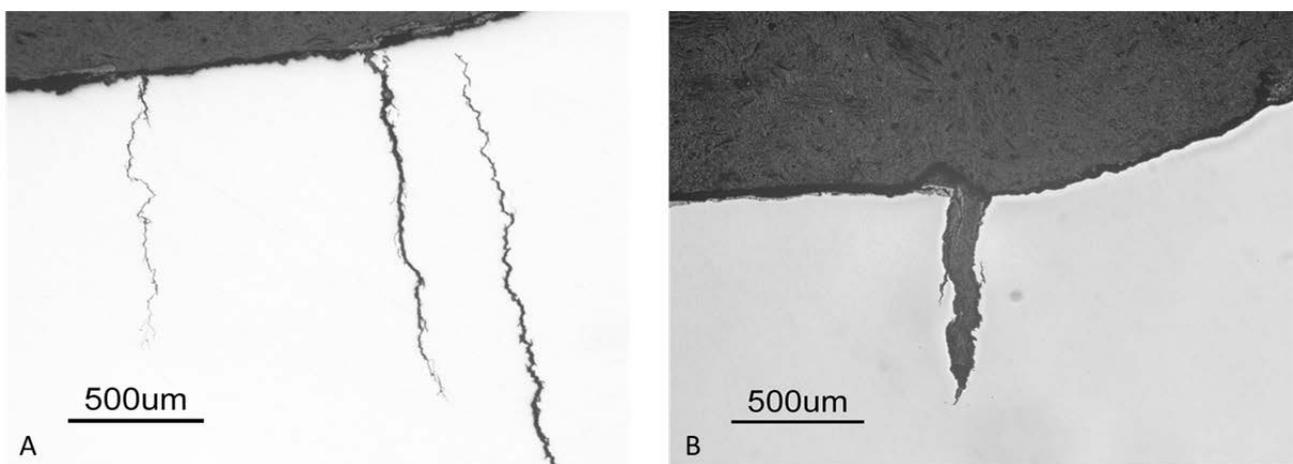
Two quite different types of subcritical crack were observed, as shown in Figure 4. The first were narrow cracks with minimal lateral corrosion of the crack walls Figure 4(a), while the second were broader cracks which had undergone substantial lateral corrosion of the crack walls, Figure 4(b). Only one type of cracking was, however, observed in any given rockbolt.

The rockbolt shown in Figure 4(a) was from Mine B which had a high pH/high bicarbonate groundwater, whereas the rockbolt shown in Figure 4(b) was from Mine A which had a near neutral pH low bicarbonate groundwater (Table 4). These findings are consistent with the prior findings for pipeline SCC and, accordingly, the two types of crack will hereafter be referred to as high pH and near neutral SCC.

**Figure 4** Subcritical cracks (A) in Rockbolt 5 (B) in Rockbolt 1

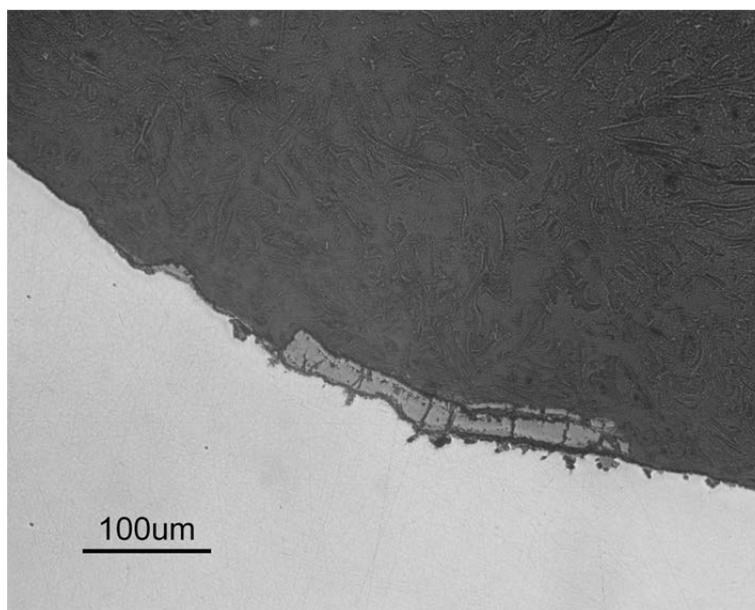
Careful examination of the surface of Rockbolt 1 (near neutral environment) revealed that, in the early stages of development, cracks in the rockbolt were often associated with cracks in the mill scale (Figure 5), which remains on the surface from the hot rolling process. It has been reported that mill scale is expected to be a factor in near neutral pH SCC of pipelines (Beavers and Harle, 2001). No association between cracking of the mill scale and the underlying cracks in the rockbolts has been observed to date for the high pH environment in the present study, but mill scale has been reported to contribute to the formation of high pH SCC of pipeline steels (Beavers and Harle, 2001).

**Figure 5** Cracks in Rockbolt 1 emanating from cracks in mill scale

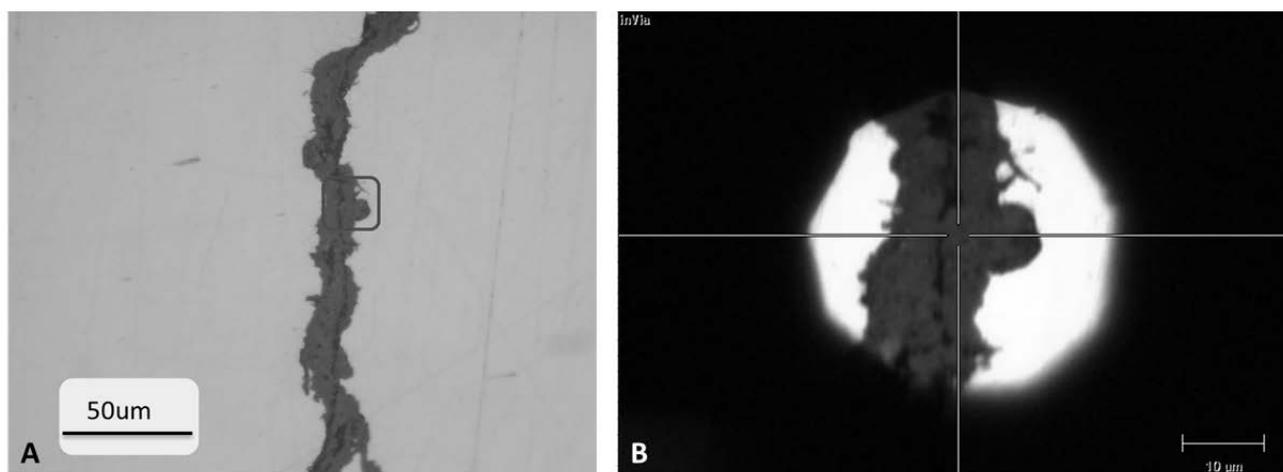
Analysis of the corrosion product was undertaken using microRaman spectroscopy for the high pH and near neutral cracks. The high pH crack examined (Rockbolt 5) is shown in Figure 6, while the spectrum obtained is shown in Figure 7. Comparison of the spectrum with the Renishaw database indicated that the main component of the corrosion product was  $\text{FeCO}_3$  (siderite), consistent with the proposed carbonate cracking mechanism.

**Figure 6** High pH crack in Rockbolt 5: (A) optical microscope image; (B) raman microscope image of boxed region in (A). Cross hairs in (B) show site of analysis

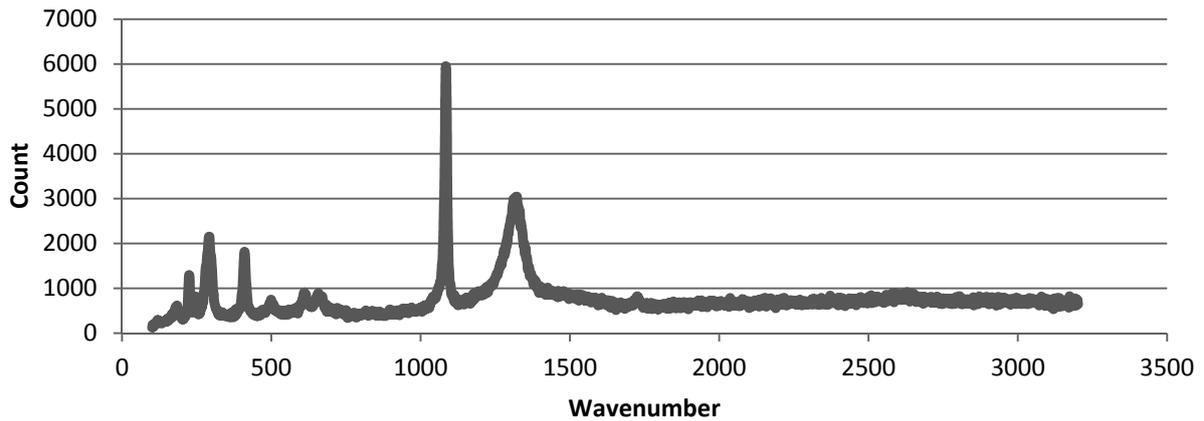
**Figure 7** Raman spectrum of corrosion product in high pH crack shown in Figure 6

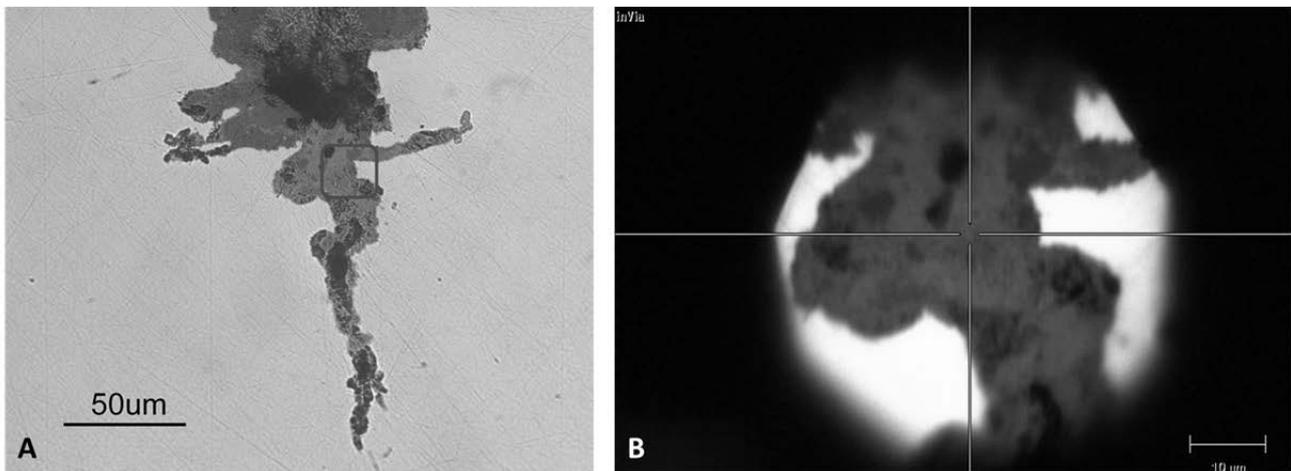
The near neutral pH crack (Rockbolt 1) in which the corrosion product was analysed is shown in Figure 8. In this case, analysis of the spectrum, Figure 9, using the Renishaw database indicated that the main component of the corrosion product was  $\text{Fe}_3\text{O}_4$  (magnetite).

**Figure 8** Near neutral pH crack in Rockbolt 1: (A) optical microscope image; (B) Raman microscope image of boxed region in (A). Cross hairs in (B) show site of analysis

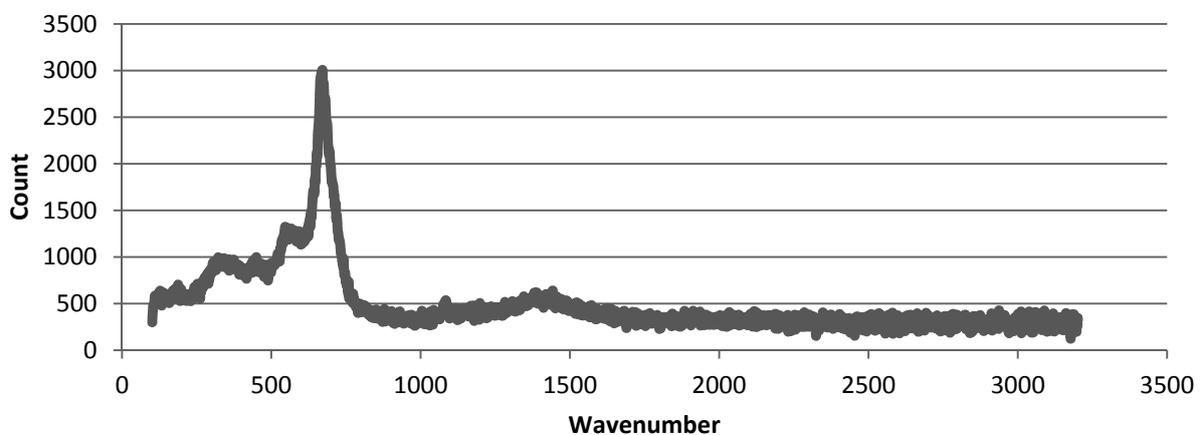
**Figure 9** Raman spectrum of corrosion product in near neutral pH crack shown in Figure 8

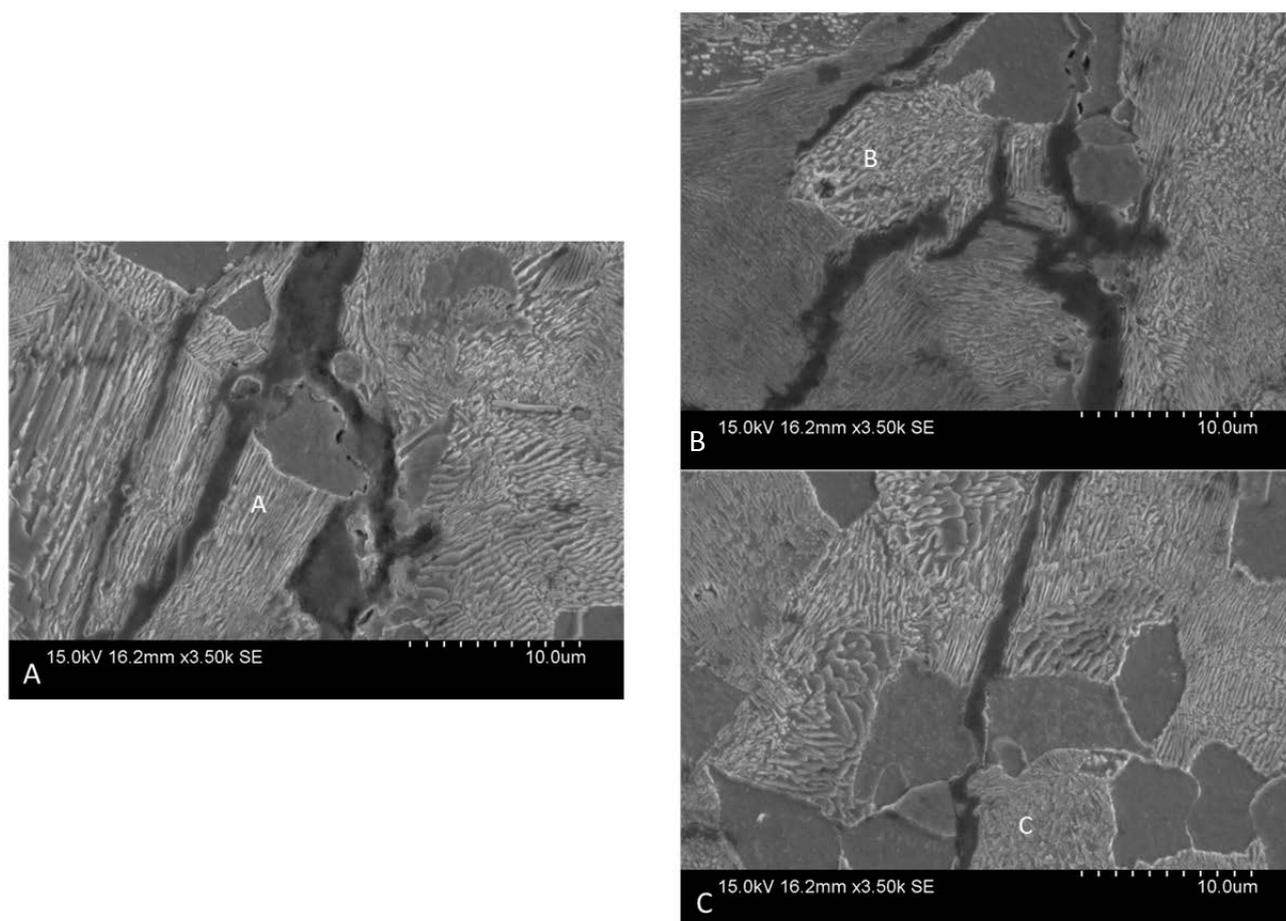
Optical micrograph of the crack path for a high pH crack (Rockbolt 5) in the low silicon 840 grade steel (ferrite/pearlite structure) is shown in Figure 10. The crack can be seen to run through the pearlite between the individual lamellae (Region A), where the colonies are oriented approximately parallel to the macroscopic crack direction, but between the colonies (Region B), or along the ferrite/pearlite boundaries (Region C), where the pearlite colonies are oriented more perpendicular to the macroscopic crack direction. Similar behaviour has been reported for in-service SCC of X52 pipeline steel (Li et al., 2006).

**Figure 10** SEM images showing the crack path for a high pH crack in a low silicon 840 Grade steel rockbolt. The crack runs between the pearlite lamellae in the region marked A, between the pearlite colonies in the region marked B and along the pearlite/ferrite boundary in the region marked C

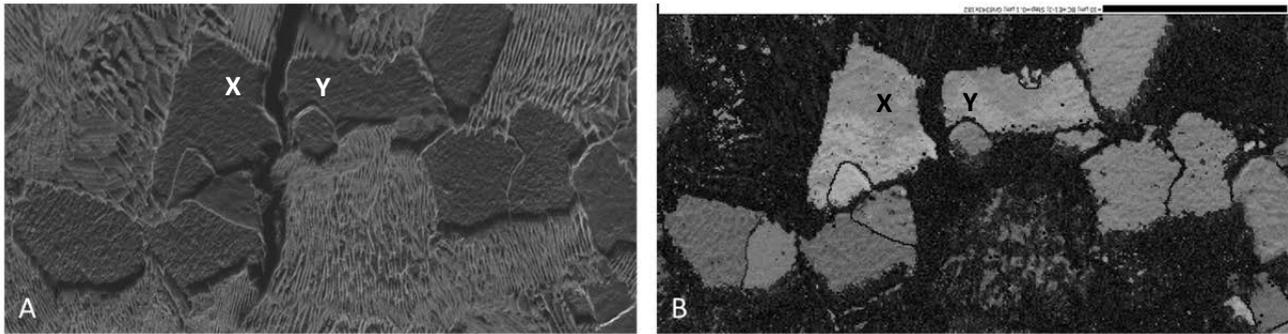
An SEM micrograph and matching EBSD image of the region of the crack shown in Figure 10c is shown in Figure 11. The crack passes through two adjoining regions of ferrite labelled X and Y in Figure 11(a). EBSD indicated that these two regions have the same orientation Figure 11(b), thus establishing that crack is cutting through a ferrite grain, and not running along the boundary between two adjoining grains.

**Figure 11** SEM micrograph and matching EBSD image of crack running through two adjoining regions (marked X and Y) of ferrite

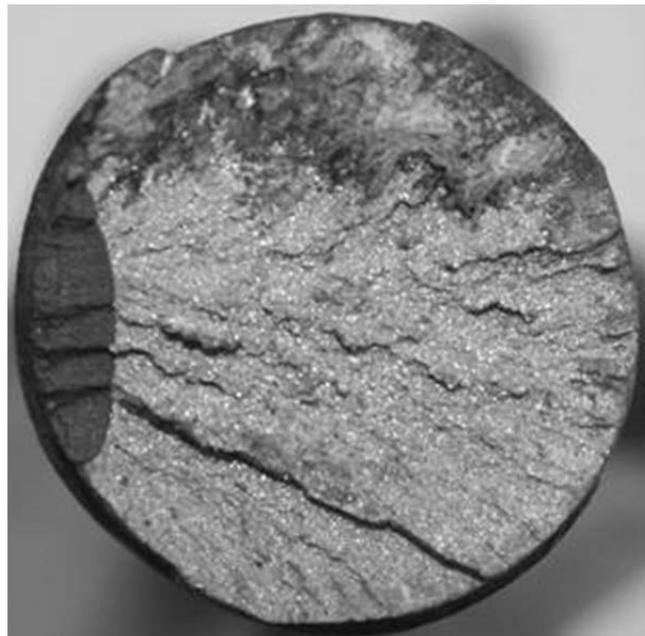
An optical fractograph showing the fracture surface of Rockbolt 1 is given in Figure 12. The fracture surface exhibits a thumbnail-shaped discoloured region produced during propagation of the stress corrosion crack, followed by a bright region produced by the final catastrophic overload failure. SEM fractographs of the SCC region and the overload region are shown in Figure 13(a) and (b), respectively. The two regions are distinctly different, with Figure 13(a) showing the features characteristic of SCC while Figure 13(b) shows the features characteristic of brittle overload failure, as reported previously (Crosky et al., 2012; 2004; 2002). It is noted that rockbolts show ductile overload when tested in tension. The brittle overload seen in the SCC failed rockbolts is due to the stress concentrating effect of the notch produced by the sharp stress corrosion crack.

**Figure 12** Optical fractograph of Rockbolt 1

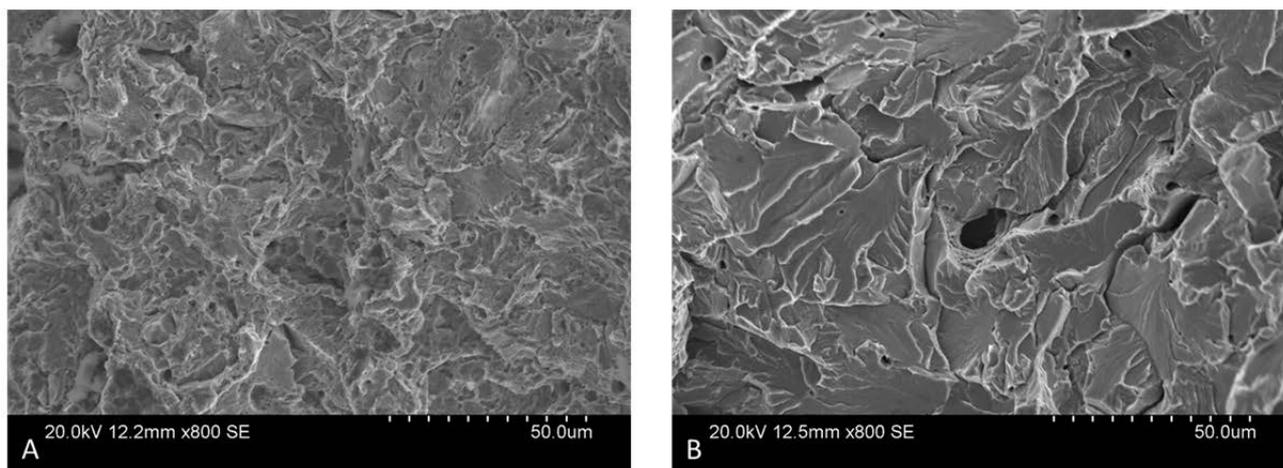
**Figure 13 SEM fractographs of Rockbolt 1 (A) SCC region, (B) overload region**
