An Investigation of the Corrosive Impact of Groundwater on Rock Bolts in Underground Coalmines

P Craig¹, S Saydam², P Hagan³, B Hebblewhite⁴, D Vandermaat⁵, A Crosky⁶ and E Elias⁷

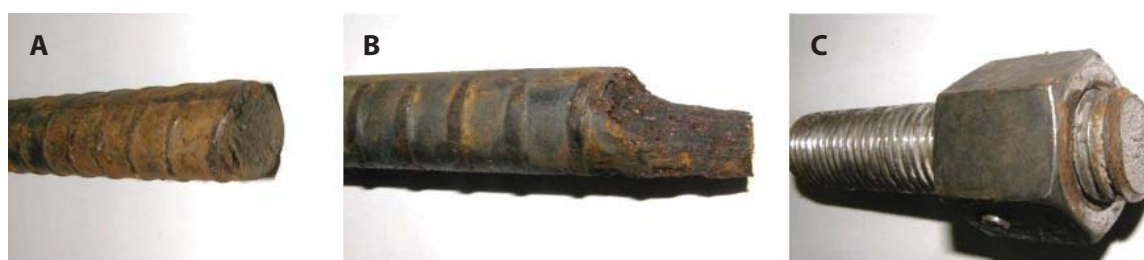
Since 2010, approximately 200 broken rock bolts have been collected from 12 Australian coalmines and received into UNSW laboratories for various analyses. All of the rock bolts are 22 mm core diameter, 'X' grade steel, which is typically >600 MPa yield and >840 MPa UTS. Three main failure modes are visually evident as shown in Figure 1 and are generally described as:

- rebar SCC
- localised pitting corrosion
- thread SCC.

FIG 1 – (A) Rebar stress corrosion cracking; (B) localised pitting corrosion; (C) thread stress corrosion cracking.

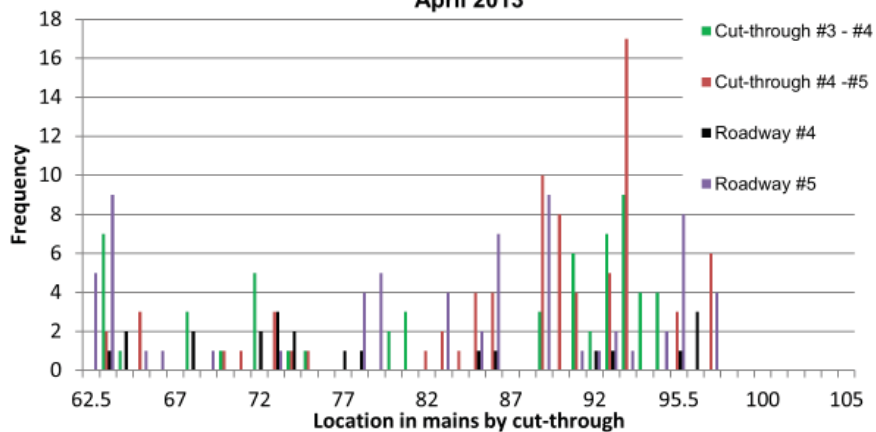
Figure 3 graphically represents the number of broken bolts per location along the two main heading roadways. The immediate finding is that age of the headings is not strongly related to the frequency of broken bolts in the mains. A total of 226 broken bolts were discovered, with the cut-throughs accounting for 60 per cent of the failed bolts and heading #5 on the far right accounting for 30 per cent of the failed bolts. Where possible, a tape measure was placed into drill holes where bolts were missing and the distance to the break location measured. The mine records had shown an increase in resin capsule length to improve bolt encapsulation in heading #5 from 89 c/t onwards. The bolt break lengths were averaged before and after 89 c/t, and found to be 290 mm before increasing resin encapsulation and 166 mm after increasing encapsulation. The number of broken bolts in heading #5 in the ~2 km before 89 c/t accounted for 40 per cent of broken bolts, whilst the ~1 km of heading #5 driven with the longer resin capsules accounted for 60 per cent of broken bolts. Strong conclusions cannot be made about the effect of bolt encapsulation as it will be shown that groundwater flow rates had a big impact on the number of broken bolts inbye of 89 c/t.

FIG 3 – Mine 1 'mains': underground survey of broken Bolts.

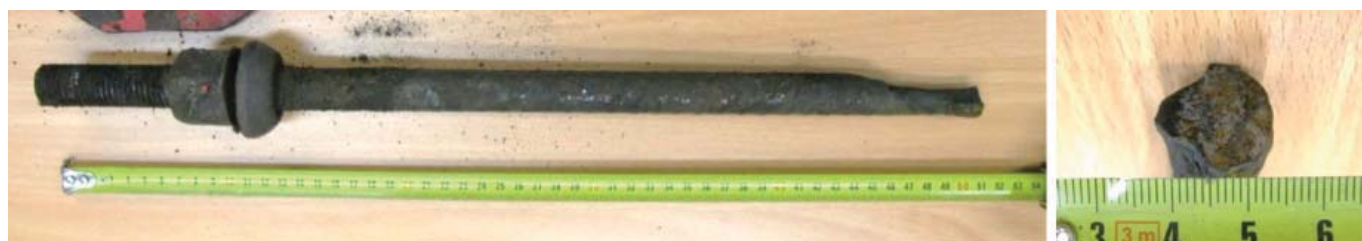
The selected worst case areas of the first mains resulted in five from 98 visually intact rock bolts (five per cent) failing the load tests. Three of the failures were between 14–17 t and when pulled completely from the roof a bolt was suffering loss cross-section due to localised pitting, this bolt is shown in Figure 4. Prior to load testing, these failed bolts did not produce signal reflection by the ultrasonic NDT as the sound waves would have been deflected at the reduced cross-section rather than reflected back to the probe. These findings raise the possibility of bolts passing the 18 t load test yet being seriously compromised by loss of cross-section.

FIG 4 – Mine 3: bolt broken at 15 t during load test.

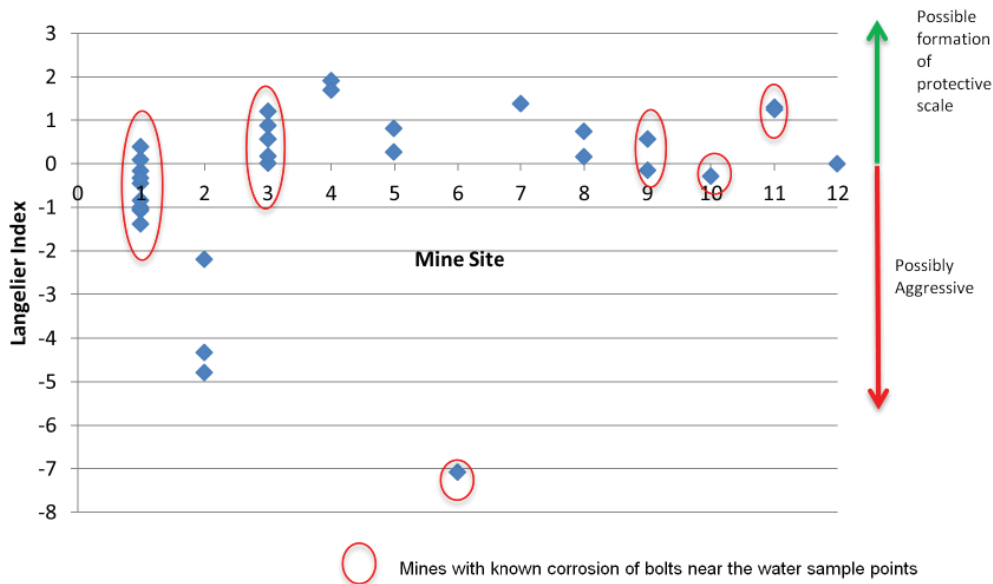
Figure 6 graphically represents the LSI rating for the Australian coalmine bolt dripper groundwater analysed by the project to date, on a mine by mine basis. It is clear that the LSI does not correlate as Mines 3, 9 and 11 are showing possible protective scale, but these mines have had numerous corroded bolts within the groundwater sampling locations. The LSI is not useful for Australian coalmine groundwater corrosivity due to the Cl^- concentrations exceeding 25 ppm at nine of the 12 mines (Sastra *et al*, 1994), which was also the finding from the Western Australia School of Mines (WASM) study into Australian Hard rock mine water conducted by Villaescusa, Hassell and Thompson (2008). As shown in Table 3, the Australian coalmine groundwater had very small amounts of aggressive chloride and sulfate compared to the WASM Australian Hard rock groundwater study.

FIG 6 – Australian coalmine groundwater: Langelier saturation index and known corrosion of rock bolts.

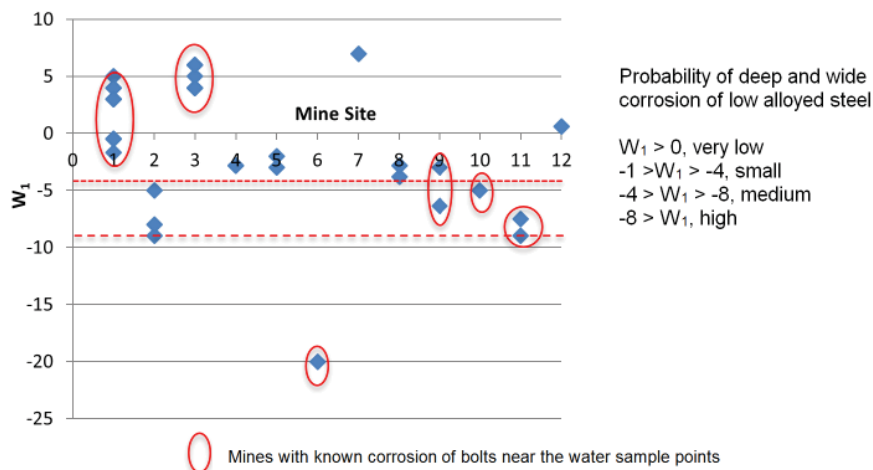
Figure 7 graphically represents the DIN corrosivity rating for the Australian coalmine bolt dripper groundwater sample analysed by the project to date, on a mine by mine basis. The DIN classification will not be discounted at this stage in the project due to good correlation with Mines 6, 9, 10 and 11. Mines 1 and 3 which do not correlate have significant clay bands in the bolted horizon, which may have a greater impact on corrosion than the groundwater alone.

FIG 7 – Australian coalmine groundwater: DIN rating and known corrosion of rock bolts.

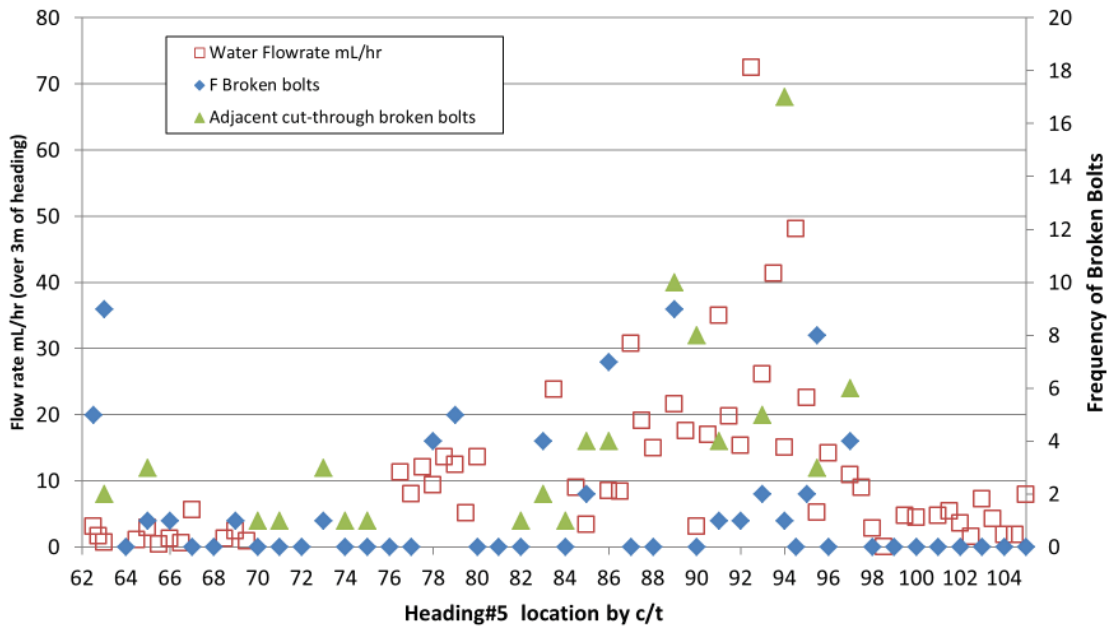
The flow rate from Mine 1 heading #5 is plotted in Figure 8 along with the frequency of broken bolt in heading #5 and

the adjacent cut-through. There is a good correlation between flow rate in heading #5 and the number of broken bolts, especially in the cut-throughs. The cut-throughs were noted as not having groundwater drip from bolts but these roadways are higher stresses due to the horizontal stress direction. With reference to Figure 2, the higher flow rates measured between ~85–95 c/t coincide with the proximity of the abandoned flooded old mine workings some 200 m away up-dip within the seam. The mine site had completed permeability testing in the area in 2003, and obtained an average of 4.98 L/min/m within the coal seam and was considerably more permeable than the surrounding rock strata.

FIG 8 – Mine 1 ‘mains’: roof ‘dripper’ flow rate in heading #5 correlation to broken bolt location.

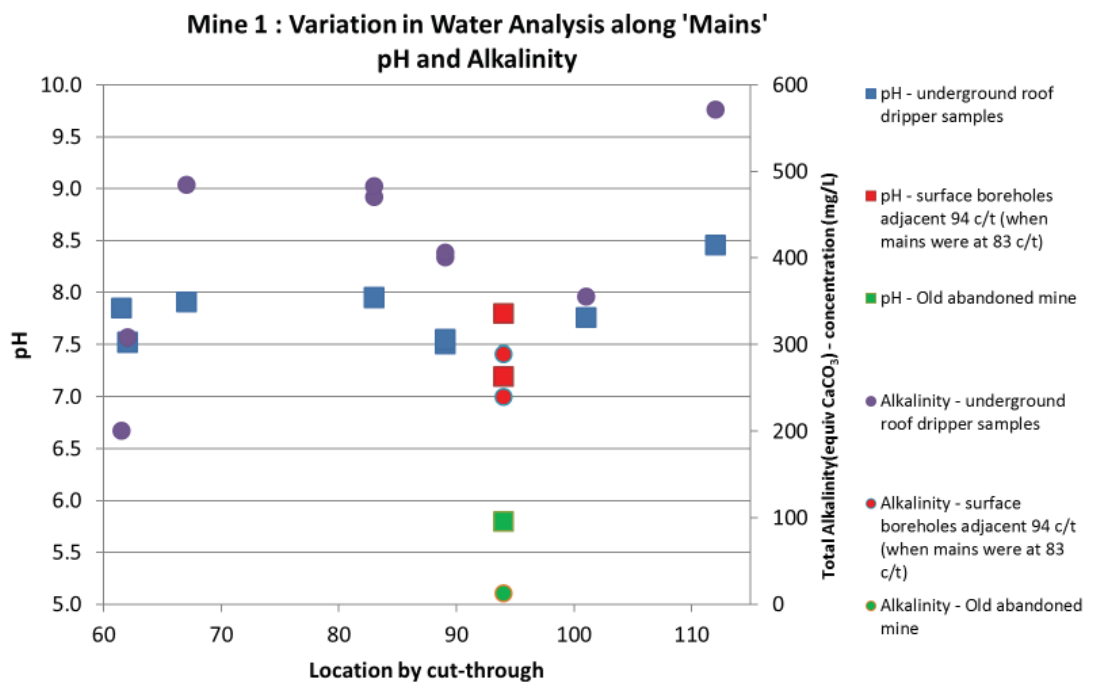
close proximity to the now completed 94 c/t area of the mains and from the old flooded mine. Figure 9 shows generally that there is only minor variation of the groundwater coming from rock bolt drippers along the main headings. The groundwater analysis from the surface boreholes in 2003 gave similar results to rock bolt drippers after the mains headings were driven into that area many years later. The up-dip old abandoned flooded mine workings are the most likely source of the water as indicated by flow rate trends, but the chemical analysis of the assumed stagnant water sampled from the working in 2003 are very different to the flowing rock bolt drippers ~200 m down dip from the workings. In terms of corrosion, the pH 5.8 water from the old workings would have given a false indication of corrosion mechanism and severity compared to the surface borehole samples of pH 7.2–7.8, which proved to be closer to the actual groundwater coming into the roadways.

FIG 9 – Mine 1 comparison of groundwater properties.

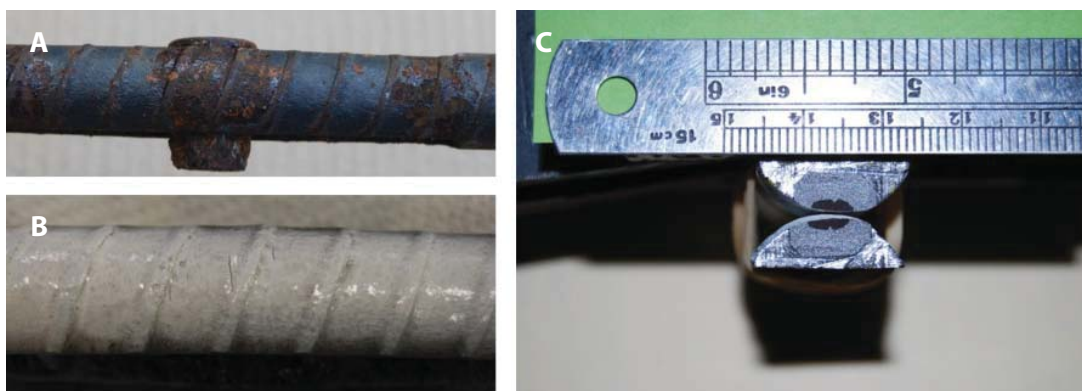
A set of five coupons made from different types of steel and surface finish were removed from Mine 1 gate road conditions after 203 days. Upon installation, a groundwater sample was taken for analysis and matched known areas of broken bolts for Mine 1. It was noted all coupon holes had groundwater dripping at installation, but at a 128 day interim inspection they were no longer dripping. Upon removal of the coupon from the drill holes, the top of the coupon contained puggy clay and approximately half a litre of groundwater above the clay plug which explains the drips ceasing over time. The coupon bolts were wrapped in plastic and transported to UNSW laboratories for cleaning and subsequent inspection for localised pitting and SCC. It was found that localised pitting corrosion was underway within the stressed section at the claystone, and in particular at points on the rebar where mill scale had been cracked from the expanded 'stressed' section. The most significant finding was a subcritical stress corrosion crack on one of the stressed sections below the claystone, this section is pictured in Figure 11 before and after inspection.

FIG 11 – In-hole coupon removal after ~200 days. (A) Stressed section of coupon after cleaning; (B) magnetic particle inspection revealing a crack; (C) crack opened confirming stress corrosion cracking.
