Investigations Into the Corrosive Environments Contributing to Premature Failure of Australian Coal Mine Rock Bolts

34th International Conference on Ground Control in Mining

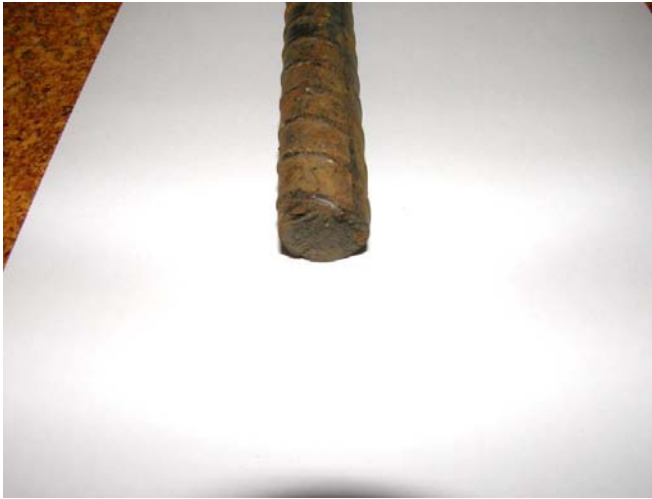
Figure 1a. Rebar SCC.

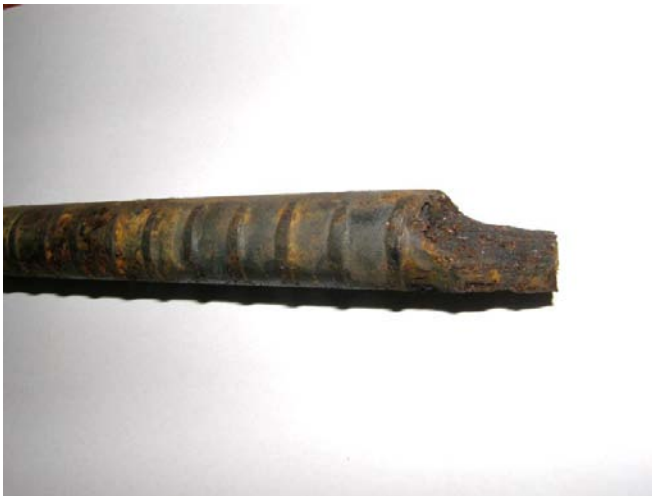
Figure 1b. Localised pitting corrosion.

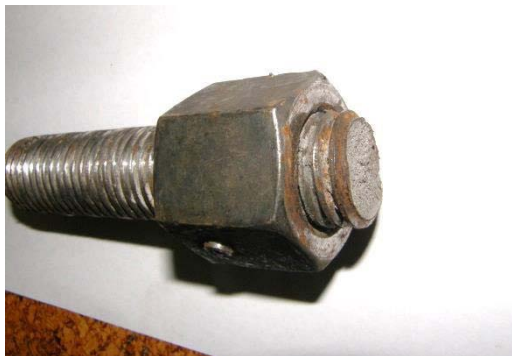
Figure 1c. Thread SCC.

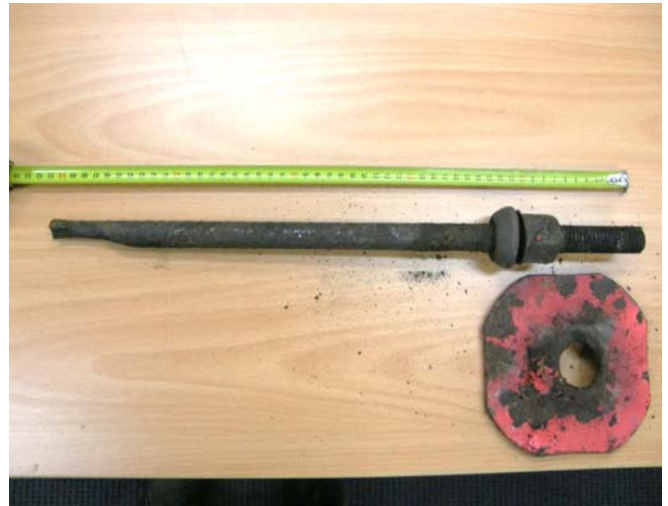
An old tailgate heading within the same mining area as the tested mains represented a total of 22 broken bolts at the UNSW laboratories. A 100m (328') length of the old tailgate was selected for survey and was visually the worst affected location in the mine. Visual inspection found 60 bolts (10%) were visually broken, and load testing to 18 tonne of 42 visually intact bolts resulted in 10 failures (24%). The ultrasound NDT indicated 7 bolts were cracked from 27 bolts tested. Two of the 7 bolts failed the load test at 2 tonne, whilst the other five passed the 18 tonne load test.

Figure 4. Severe localized pitting corrosion on load tested bolt.

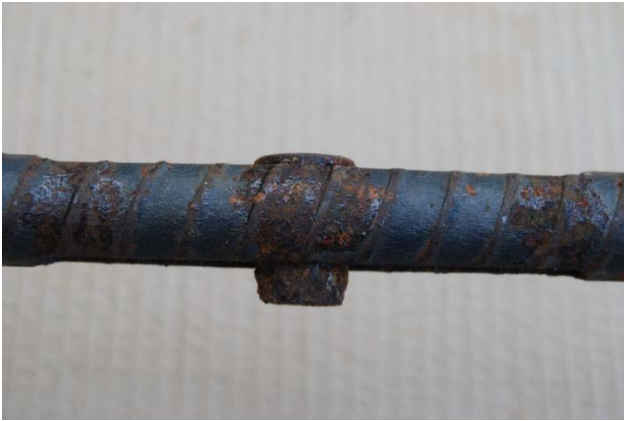
A set of five coupons made from different types of steel and surface finish were removed from Mine 1 ‘gateroad’ conditions after 203 days. Upon installation, a groundwater dripper sample was taken for analysis and matched known areas of broken bolts for Mine 1. It was noted all coupon holes had groundwater dripping at installation, but at a 128 day interim inspection they were no longer dripping. Upon removal of the coupon from the drill holes, the top of the coupon contained puggy clay and approximately half a liter of groundwater above the clay plug which explains the drips ceasing over time. The coupon bolts were wrapped in plastic and transported to UNSW laboratories for cleaning and subsequent inspection for localized pitting and SCC. It was found that localized pitting corrosion was underway within the stressed section at the claystone horizon, and in particular at points on the rebar where mill scale had been cracked from the expanded ‘stressed’ section. The most significant finding was a sub-critical stress corrosion crack on one of the stressed sections below the claystone, this section is pictured in Figure 9a, Figure 9b, and Figure 9c before and after inspection.

Figure 9a. Stress section of coupon.

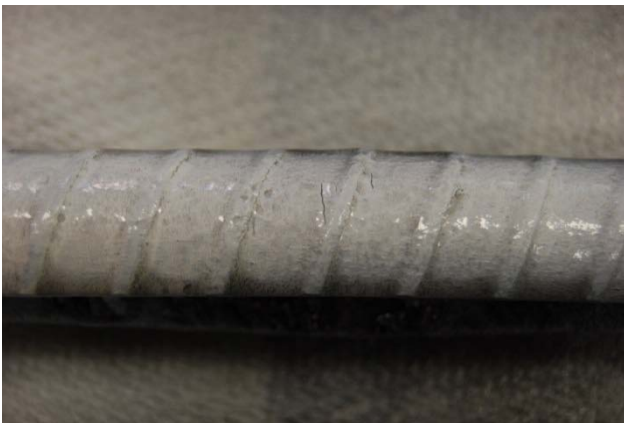
Figure 9b. Magnetic particle inspection revealing a crack.

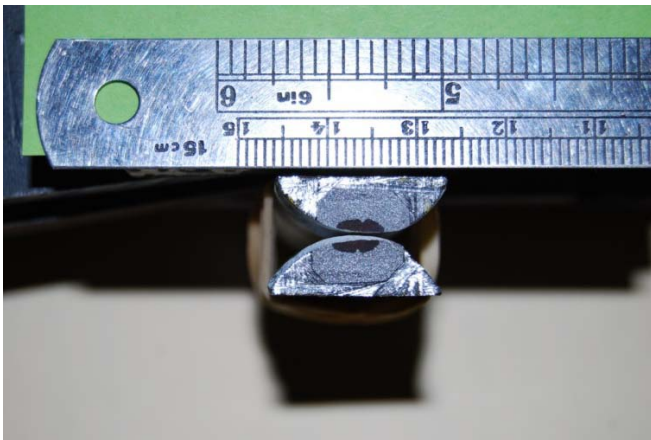
Figure 9c. Crack opened confirming SCC.
