An Investigation of the Corrosive Impact of Groundwater on Rock Bolts in Underground Coalmines

P Craig¹, S Saydam², P Hagan³, B Hebblewhite⁴, D Vandermaat⁵, A Crosky⁶ and E Elias⁷

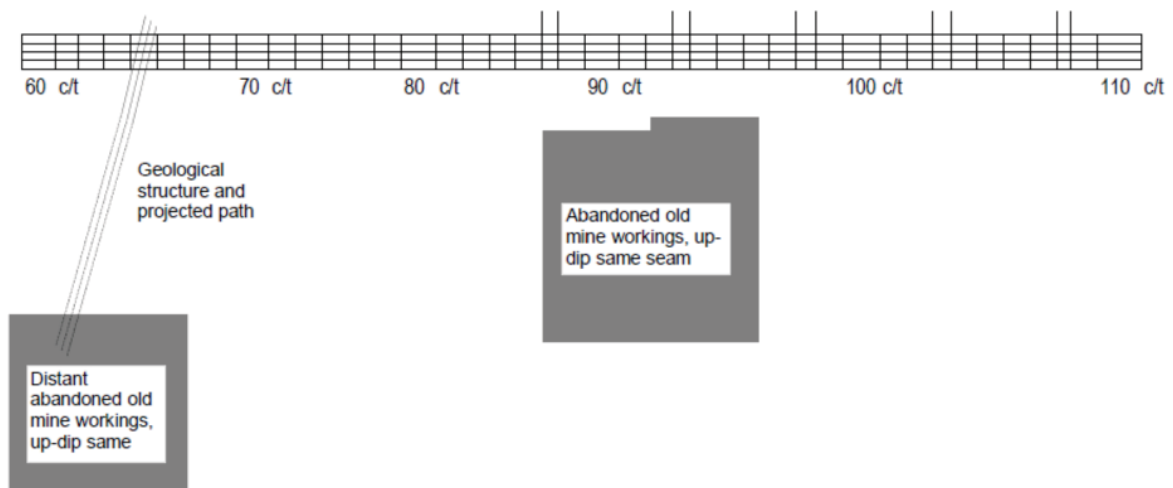
FIG 2 – Sketch of Mine 1 main roadways and associated features.

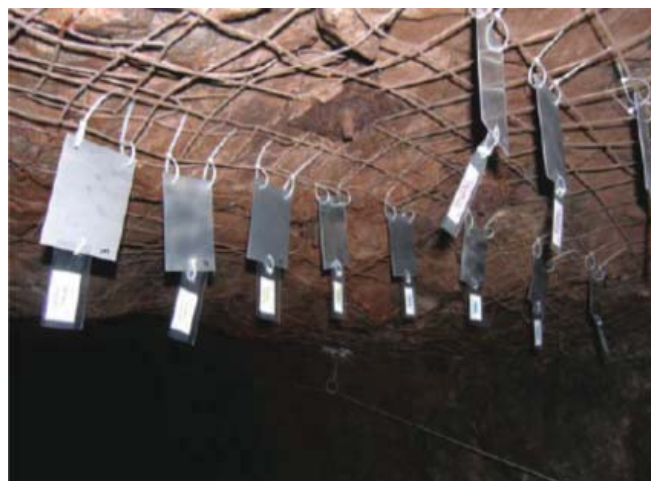
FIG 5 – ASTM Standard G4 coupons (Dorion, Hadjigeorgiou and Ghali, 2009).

Carefully prepared steel coupons such as those shown in Figure 5 have been essential in building successful corrosivity classification systems based on uniform corrosion rates. The problem in ground support is not typically uniform corrosion and other types of coupon tests have been tried by different researchers. Satola and Aromaa (2003) and then Spearing, Mondal and Bylapudi (2010) immersed complete rebar and cable bolts in mine water with laboratories, neither methods produced SCC or gave grounds for a corrosivity classification. To date the current project laboratory tests conducted at UNSW laboratories as described by Vandermaat *et al* (2012b) have successfully produced SCC failures in complete rock bolts in acidic solution. The aforementioned laboratory experiments and the underground coupons described in

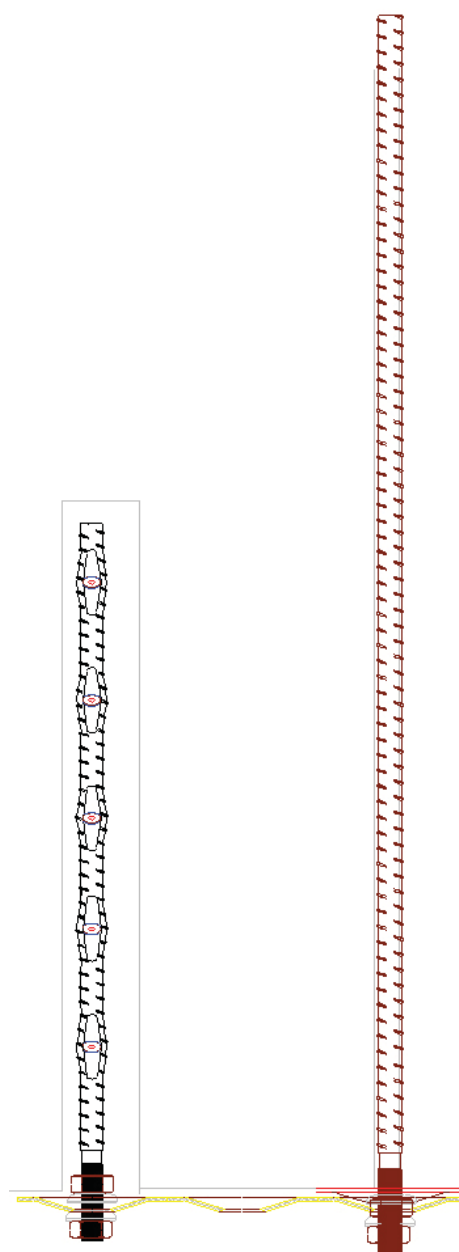
In-hole coupons constructed as shown in Figure 10 were installed in Mine 1 and Mine 3. Figure 10 shows the expanded stressed sections of rebar placed at ~200 mm centres and the entire coupon is inserted into an oversized drill hole. It is connected to an existing rock bolt to secure the coupon into the strata and to maintain connection to the existing steel mesh and adjacent bolts.

FIG 10 – In-hole corrosion coupon construction.
