Investigations Into the Corrosive Environments Contributing to Premature Failure of Australian Coal Mine Rock Bolts

34th International Conference on Ground Control in Mining

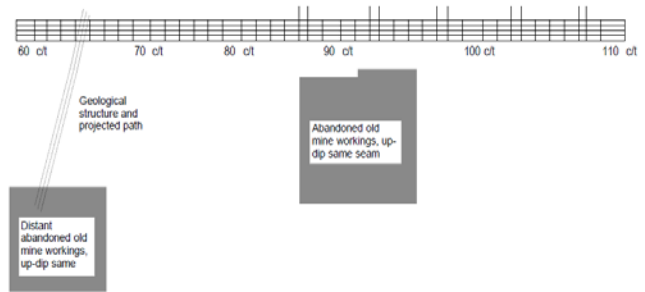
Figure 2 with respect to some major features. The support pattern included 2.1m (7') rock bolts and a mixture of 4m (13') and 8m (26') long cable bolts. The right hand side of the main roadways was known to contain the majority of broken bolts, and heading #5 was known to have water dripping from many of the roof and cable bolts. A total of 226 broken bolts were discovered, with the higher

stress cut-throughs accounting for 60% of the broken bolts and heading #5 on the far right accounting for 30% of the broken bolts. Horizontal stresses are typically most concentrated at the edge of the roadway, and this bolt location accounted for 95% of the broken bolts even when the roof showed very little visual deformation or plate loading on the bolts.

Figure 2. Schematic Mine 1 main roadways and associated features.

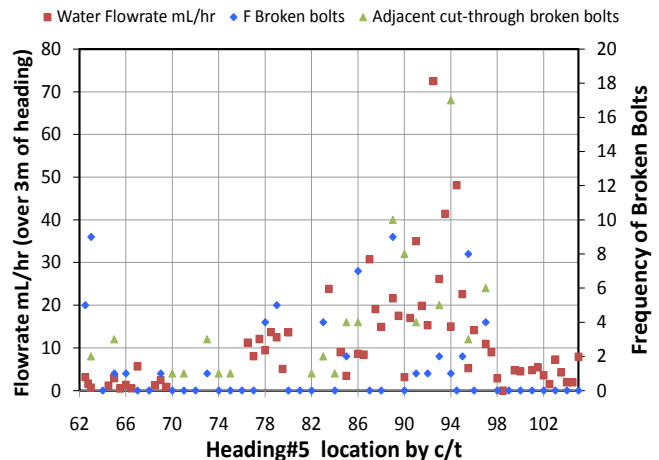
To obtain groundwater flow rate trends, each bolt/cable with water flowing (dripper) had flow measured at every intersection and mid-pillar over a selected 3m (10') length of roadway and then added together. The flow rate and frequency of broken bolts is plotted in Figure 3 showing a good correlation between groundwater flow rate in heading#5 and the number of broken bolts, especially in the cut-throughs (c/t). With reference to Figure 2, the higher flow rates measured between 85 – 95 c/t coincide with the proximity of the abandoned flooded old mine workings some 200m (650') away up-dip within the seam. Resin capsule length used with the roof bolts was increased from 1400mm (4'6") to 1700mm (5'6") at 89 c/t. The distance into the roof at which the bolts broke were found to average 290mm before increasing resin encapsulation and 166mm after increasing encapsulation. The number of broken bolts in heading#5 before 89c/t accounted for 40% of broken bolts, whilst after increasing resin capsule length accounted for 60% of broken bolts.

Figure 3. Mine 1 survey of broken bolts and drifter flowrates.

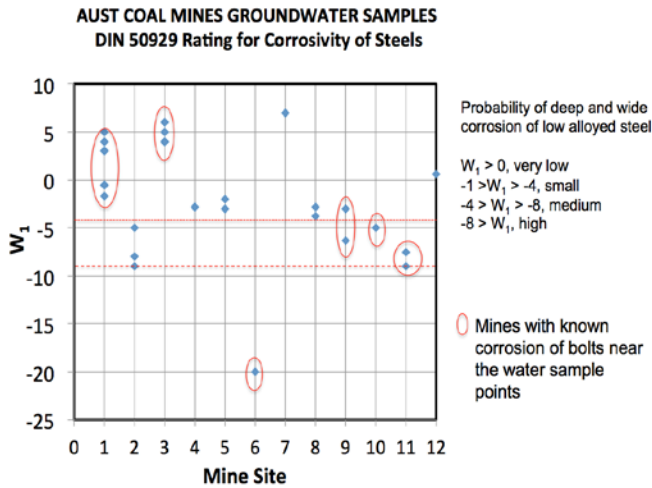
More recent hardrock mining corrosion literature from Finland by Satola and Aromaa (2003), and then from Australia by Hassal et al (2004) investigated the use of German Standard DIN 50929, which is a corrosivity classification for corrosion of metals in soils. Both studies found that the DIN corrosivity classification did not correlate to corrosion in hard rock mining applications. The DIN 50929 corrosivity classification of the Australian coal mine 'bolt dripper' groundwater is graphically represented in Figure 5, and it can be seen that no strong correlation exist with known corrosion of rock bolts in Australian coal mines. The DIN classification focusses on aggressive ions and will not be discounted at this stage in the project due to some correlation with mines 6, 9, 10 and 11.

Figure 5. DIN corrosion rating.

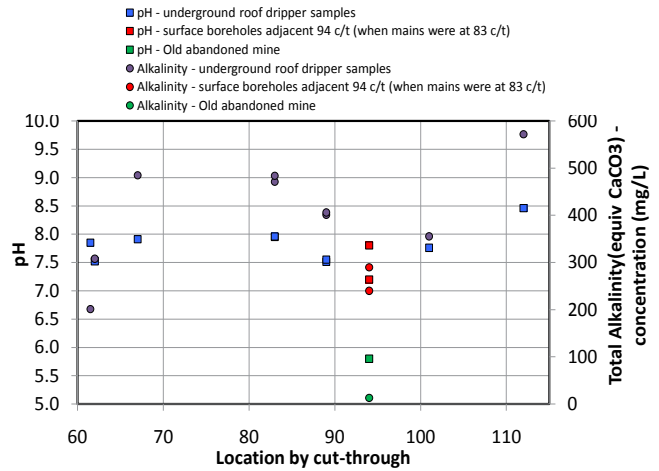
Mine 1 rock bolt dripper groundwater was sampled and analyzed every 10 pillars along the main headings from 60 – 115 c/t which also had an extensive survey of broken bolts. The groundwater was slightly alkaline at pH 7.5 – pH 8.5, and aggressive ions were at very low levels as also indicated in the DIN classification show in Figure 5. The groundwater chemistry showed only slight variation along the 55 cut-throughs and showed no correlation between aggressive ions and frequency of broken bolts.

Figure 6. Mine 1 variation in groundwater chemistry mains headings.

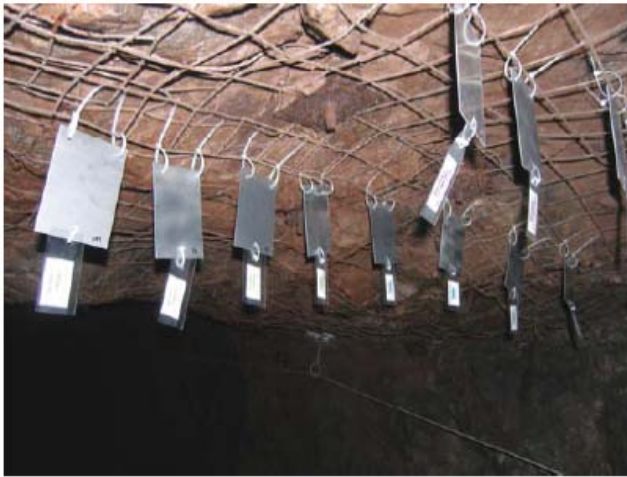
Dorion, Hadjigeorgiou and Ghali (2009) completed steel coupon testing in mine groundwater's of Canadian and Villaescusa, Hassell and Thompson (2008) in Australian hardrock mines respectively, with the aim of correlating groundwater characteristics to the general corrosion rate in millimetres per year. The coupons were carefully prepared specimens to the ASTM standard G4 as shown in Figure 7, with the surface mill scale removed. These carefully prepared steel coupons have been essential in building successful corrosivity classification systems based on uniform corrosion rates. Australian coal mine rock bolts are rebar with mill scale attached, and are suffering from localized pitting corrosion and SCC which are different mechanisms compared to general corrosion.

Figure 7. G4 coupons (Dorion, 2009).
